KNKT.08.10.23.04

Aircraft Accident Investigation Report

PT. ASI Pudjiastuti (Susi Air)

PK – VVL

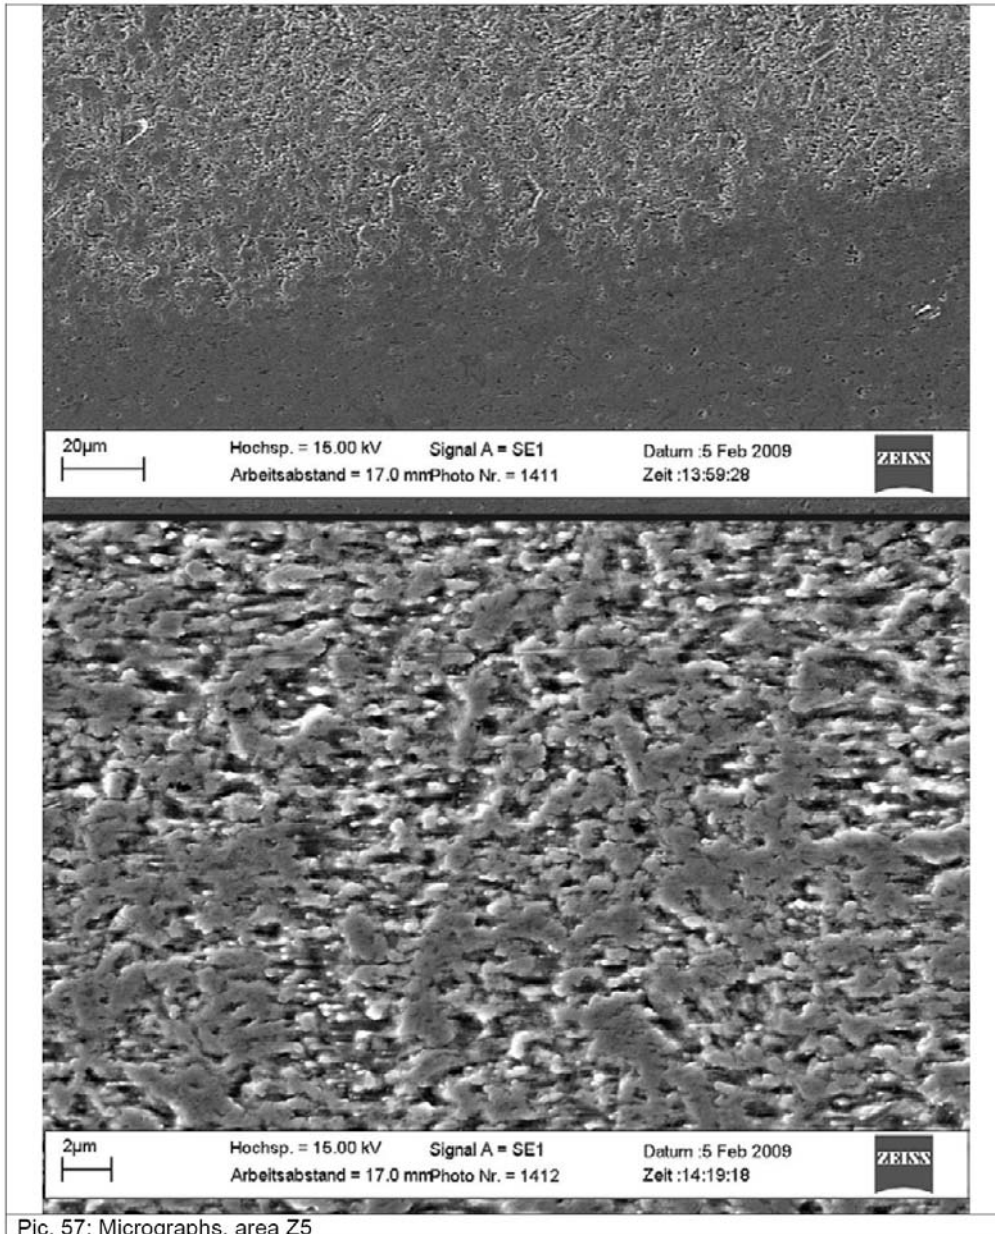
Pic. 57: Micrographs, area Z5

The micrographs show adhesive wear in area Z5 as well. The upper micrographs show various degrees of wear.

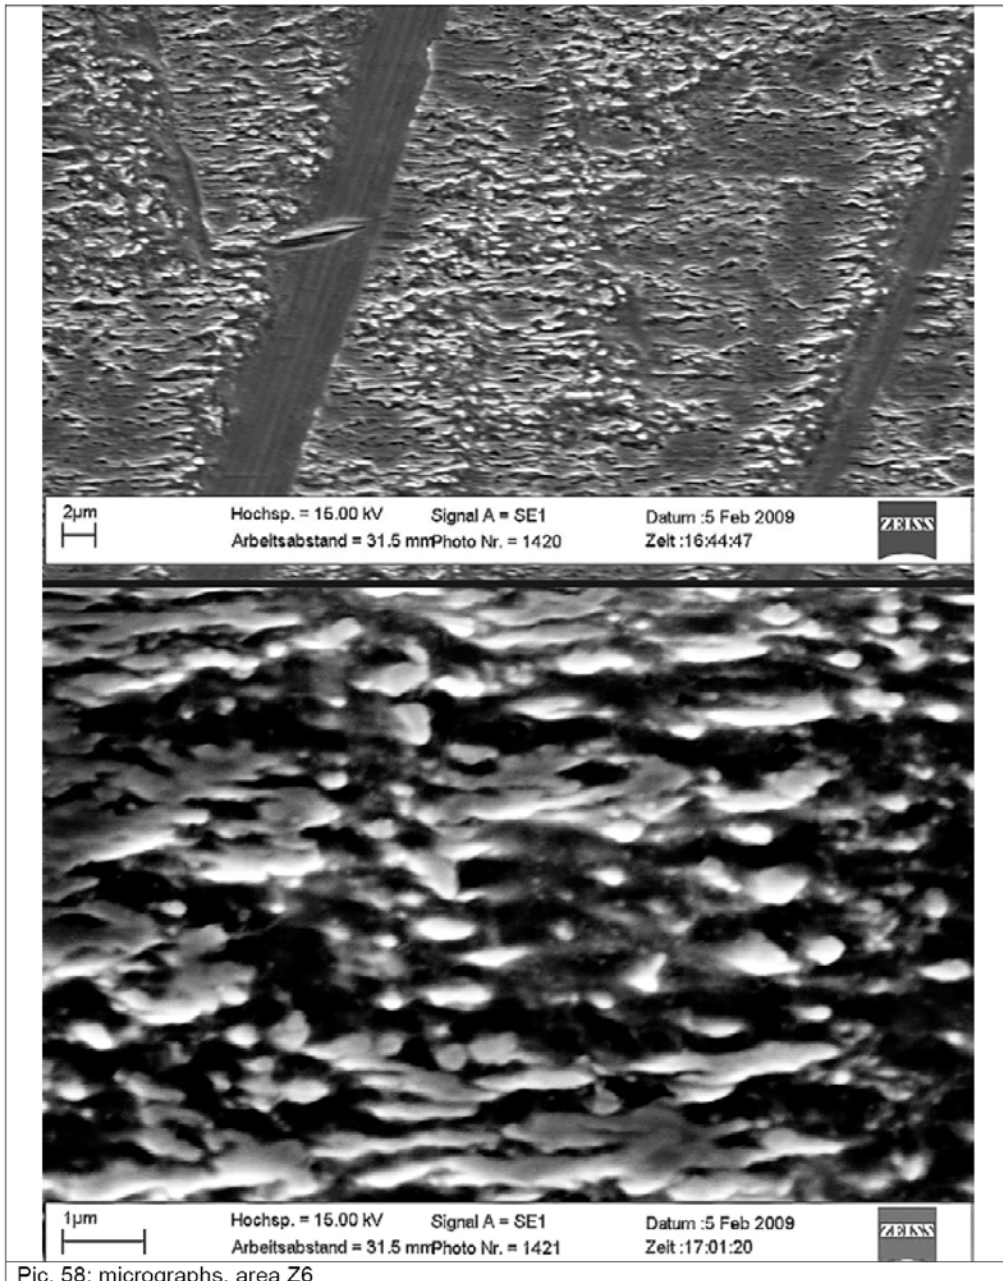
Pic. 58: micrographs, area Z6

Area Z6 shows adhesive wear. The upper micrographs show additionally traces of honing.

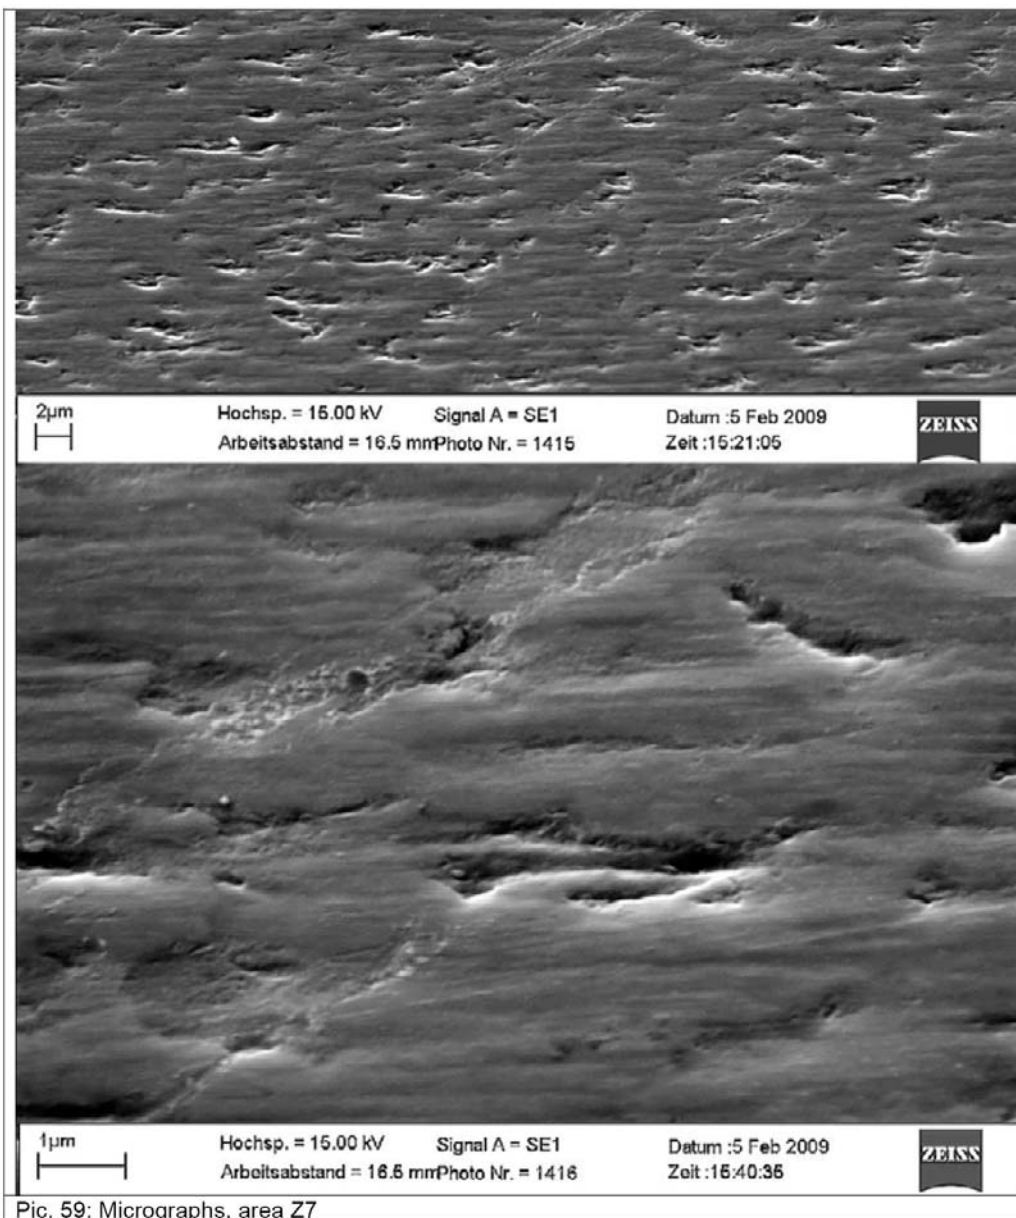
Pic. 59: Micrographs, area Z7

The area Z7 shows adhesive wear in a different state. The direction of fretting is clearly visible.
